3D LASER SCAN AND CCTV INSPECTIONS

McRobert Contracting Services provides a specialised service of completing 3D laser scan and CCTV inspections on sewer pump stations and access chambers.

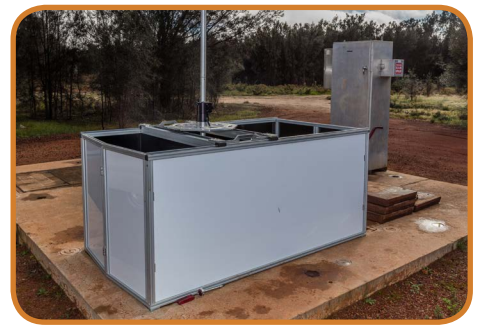
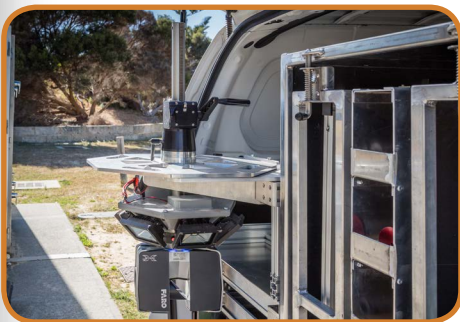
Using the latest 3D scanning technology, a Faro X130 3D laser scanner is used to provide accurate measurements of your underground asset. These measurements are then compared to the original dimensions of the structure, to determine the amount of deterioration of the asset. The laser scanner takes 27 million measurements in 8 minutes, up to a distance of 130 metres.

Data is collected from the laser scanner and used with specialised software to create 3D point cloud imagery, which is then used to assess the structural integrity of the asset walls.

In conjunction with the laser scanner, a high resolution camera is also used to visually inspect the walls and internal components of the structure. A full HD video recording of the inspection and high resolution photographs are provided as part of this service.

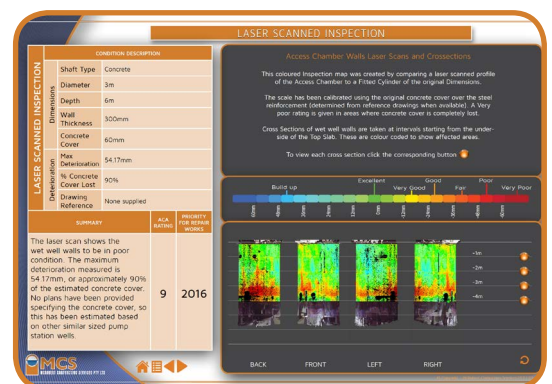
LASER SCANNED INSPECTION		Access Chamber Walls Laser Scan and Corrosion	
Dimensions	Shaft Type: Concrete Diameter: 5m Depth: 6m Wall Thickness: 300mm Concrete Cover: 60mm Max. Deterioration: 54.17mm	% Concrete Cover Left: 90% Drawing Reference: None supplied	This colour inspection was created by comparing a laser scanned profile of the Access Chamber to a Final Cylinder of the original Dimensions. The scale has been calibrated using the original concrete cover over the steel reinforcement (determined from reference drawings when available). A very poor rating is given in areas where concrete cover is completely lost. Cross Sections of wet well walls are taken at intervals starting from the underside of the Top Slab. These are colour coded to show affected areas. To view each cross section click the corresponding button.
Summary	This laser scan shows the wet well walls to be in poor condition. The maximum deterioration measured is 54.17mm, or approximately 90% of the estimated concrete cover. No plans have been provided specifying the concrete cover, so this has been estimated based on other similar sized pump station wells.	9 2016	Build up: Excellent Very Good Good Fair Very Poor BACK FRONT LEFT RIGHT
